United States Department of the Interior  
BUREAU OF LAND MANAGEMENT

Subject: Inspection of Natural Organic Fertilizer Project Area

## Inspection of Natural Fertilizer Humate Project Area

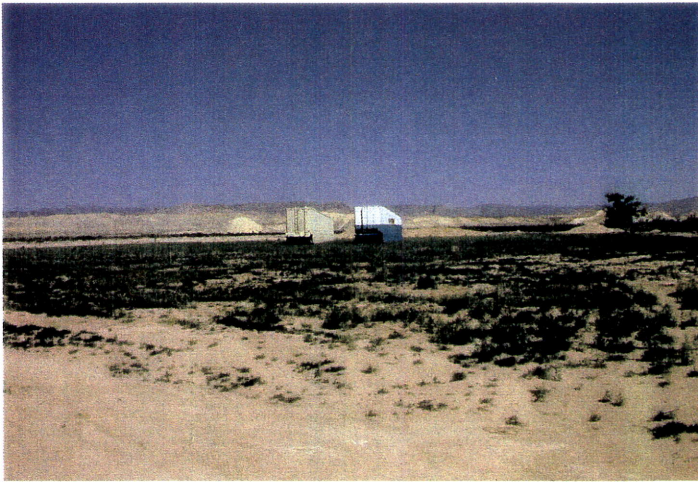
Photo 1 - Private land where processing of humates for gold and silver would occur. Abandoned semitrailers are the only equipment on the site. No signs of activity. View looking north.

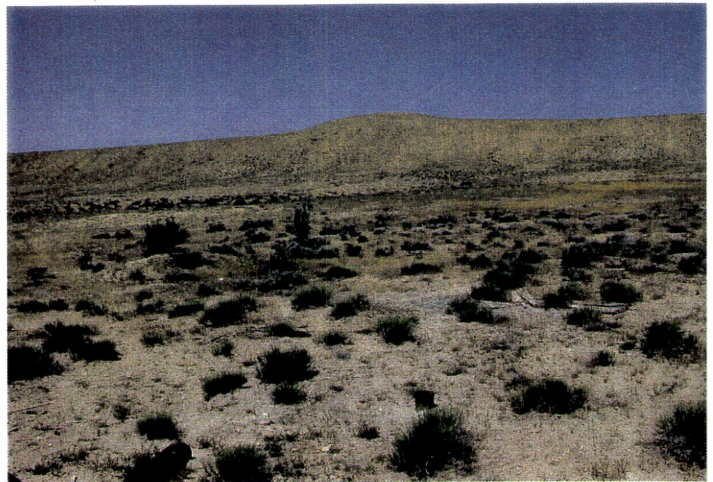
Photo 2 - View looking west from a drill hole identified on the 7½ minute topographic map. The humate deposit in the project area is found on the ridge to the south of the knoll.

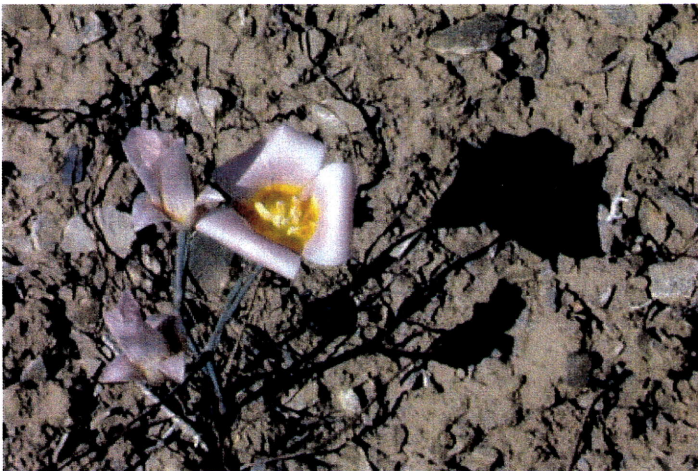
Photo 3 - Wildflowers growing on the slope below the ridge shown in Photo 2.

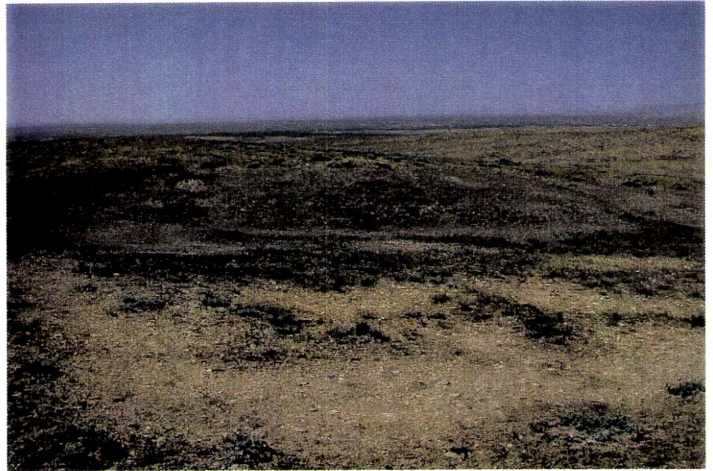
Photo 4 - Cut exposing the dark colored humates within the project area. View is to the south.

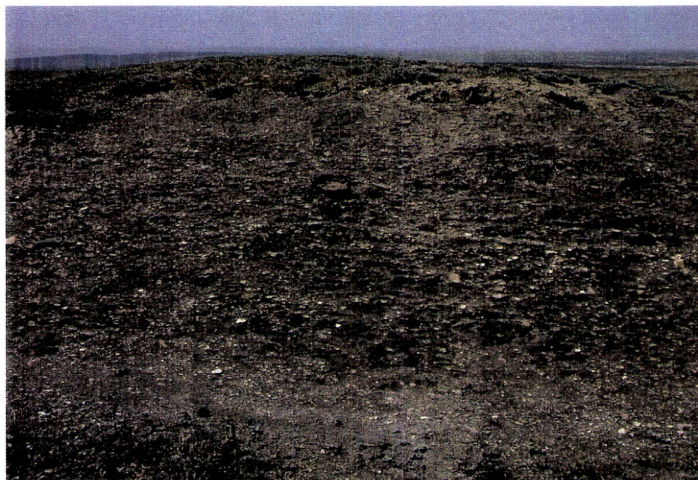
Photo 5 - Closeup of humates shown in Photo 4.

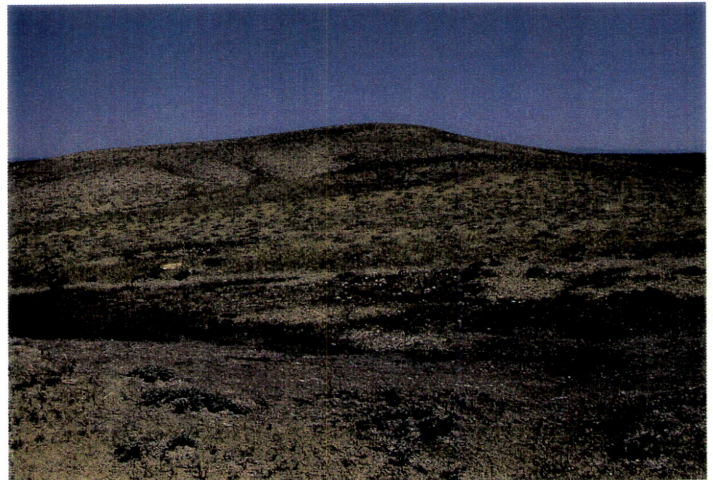
Photo 6 - View looking north. The humate deposit shown in Photo 4 is in the foreground and the knoll shown in Photo 2 is in the background.

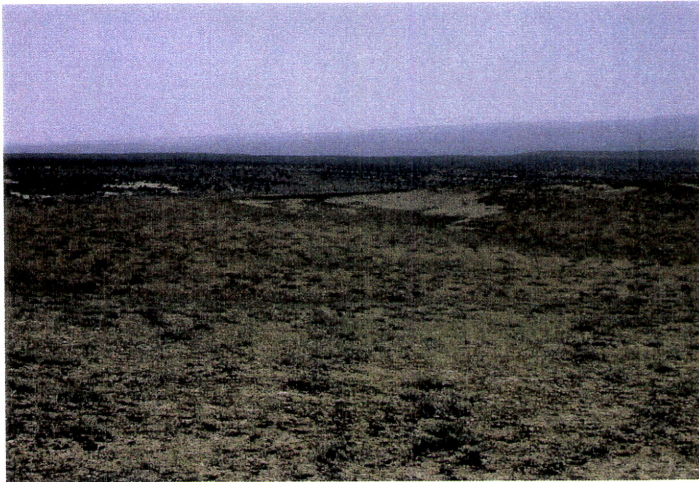
Photo 7- View looking southeast at the humate deposit shown in Photo 4.

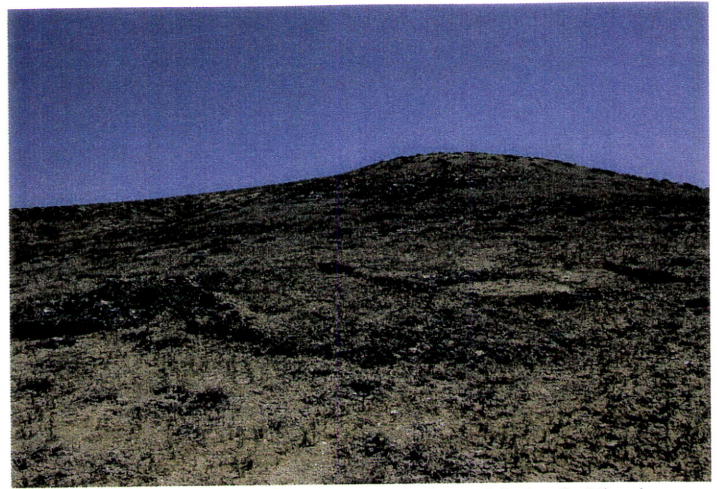
Photo 8- Another humate deposit exposed at the base of the knoll. View is looking north.

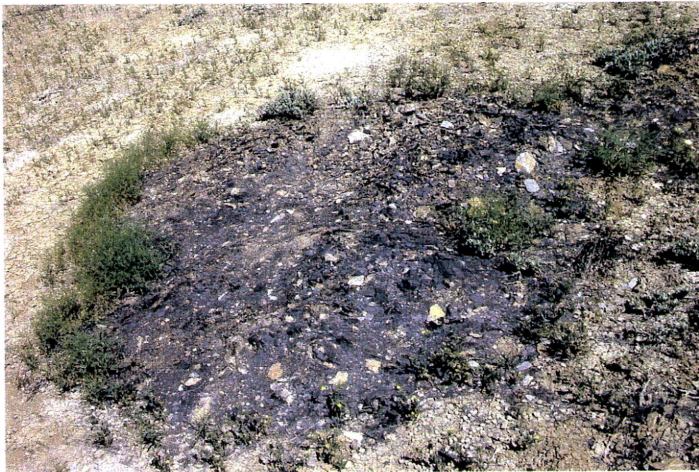
Photo 9- Closeup of humates shown in Photo 8.

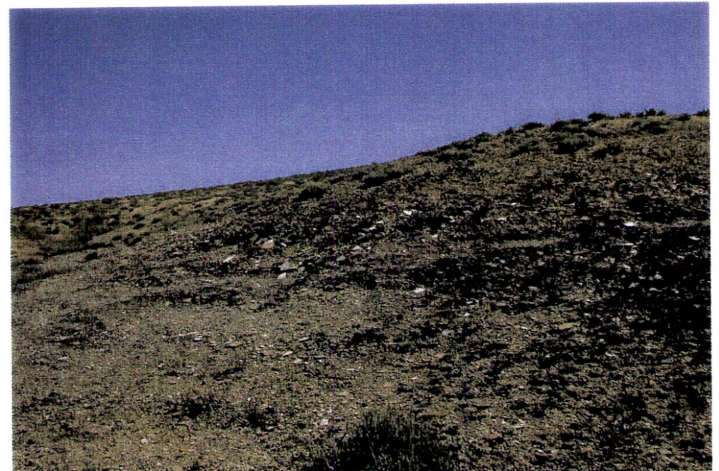
Photo 10- Humates exposed along the southwest side of the knoll.

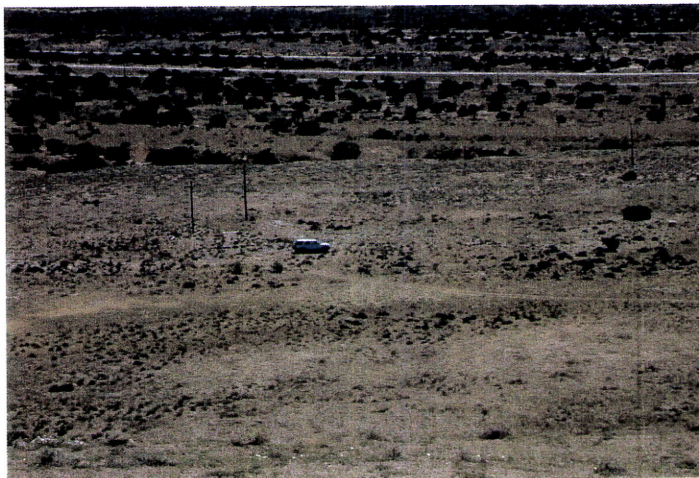
Photo 11- View looking east from the top of the knoll to the drill hole location where the government vehicle is parked.

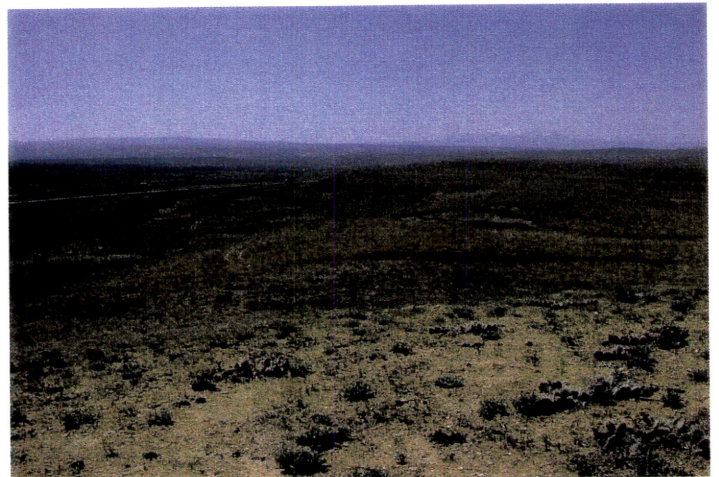
Photo 12- View looking south from the knoll across the ridge and along the length of the project area. The humate deposit shown in Photo 4 is towards the center.

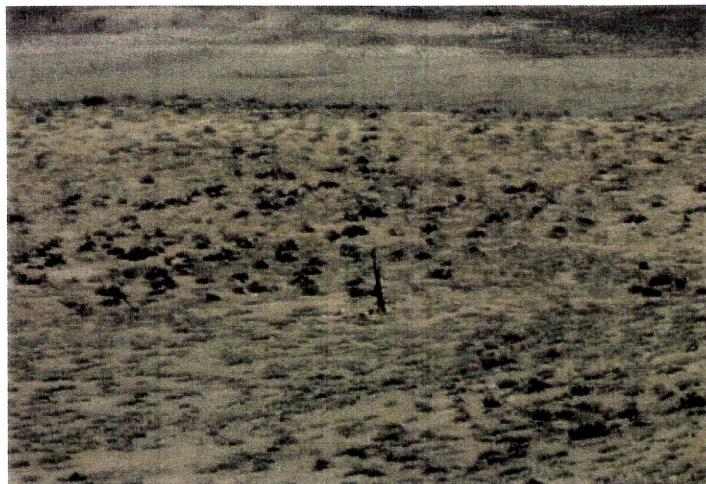
Photo 13 - View from the top of the knoll to the southwest. The erect wooden feature toward the center may be an old claim monument.

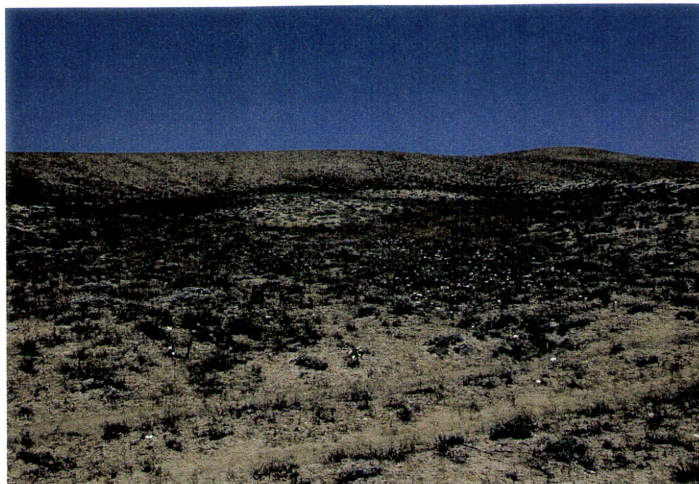
Photo 14 - The access road to the drill hole is in the foreground. From here a faint road leads to the top of the ridge. The knoll is to the right.
